**APPENDICES TO  
DRAFT ENVIRONMENTAL IMPACT REPORT  
FOR THE PAVILION AT OCEANSIDE  
P-6-06, D-5-06, C-(19-23)-06  
SCH No. 2006111033**

**E. Geotechnical Report**

Subject: Geotechnical Update  
The Pavilion at Oceanside  
North of Expressway 76 and Mission Avenue  
Oceanside, California  
APN 160-270-79

**SECOND REVISED REPORT FOR ADDITIONAL TESTING AND  
PROPOSED LOCATION FOR PLACEMENT OF  
DIELDRIN/TOXAPHENE AFFECTED SOIL  
THE PAVILION AT OCEANSIDE, APN'S 160-270-31, -73, -79  
AND 169-280-14, 48-51, 53-55, OCEANSIDE  
SAN DIEGO COUNTY, CALIFORNIA 92054 DEH CASE #H39715**

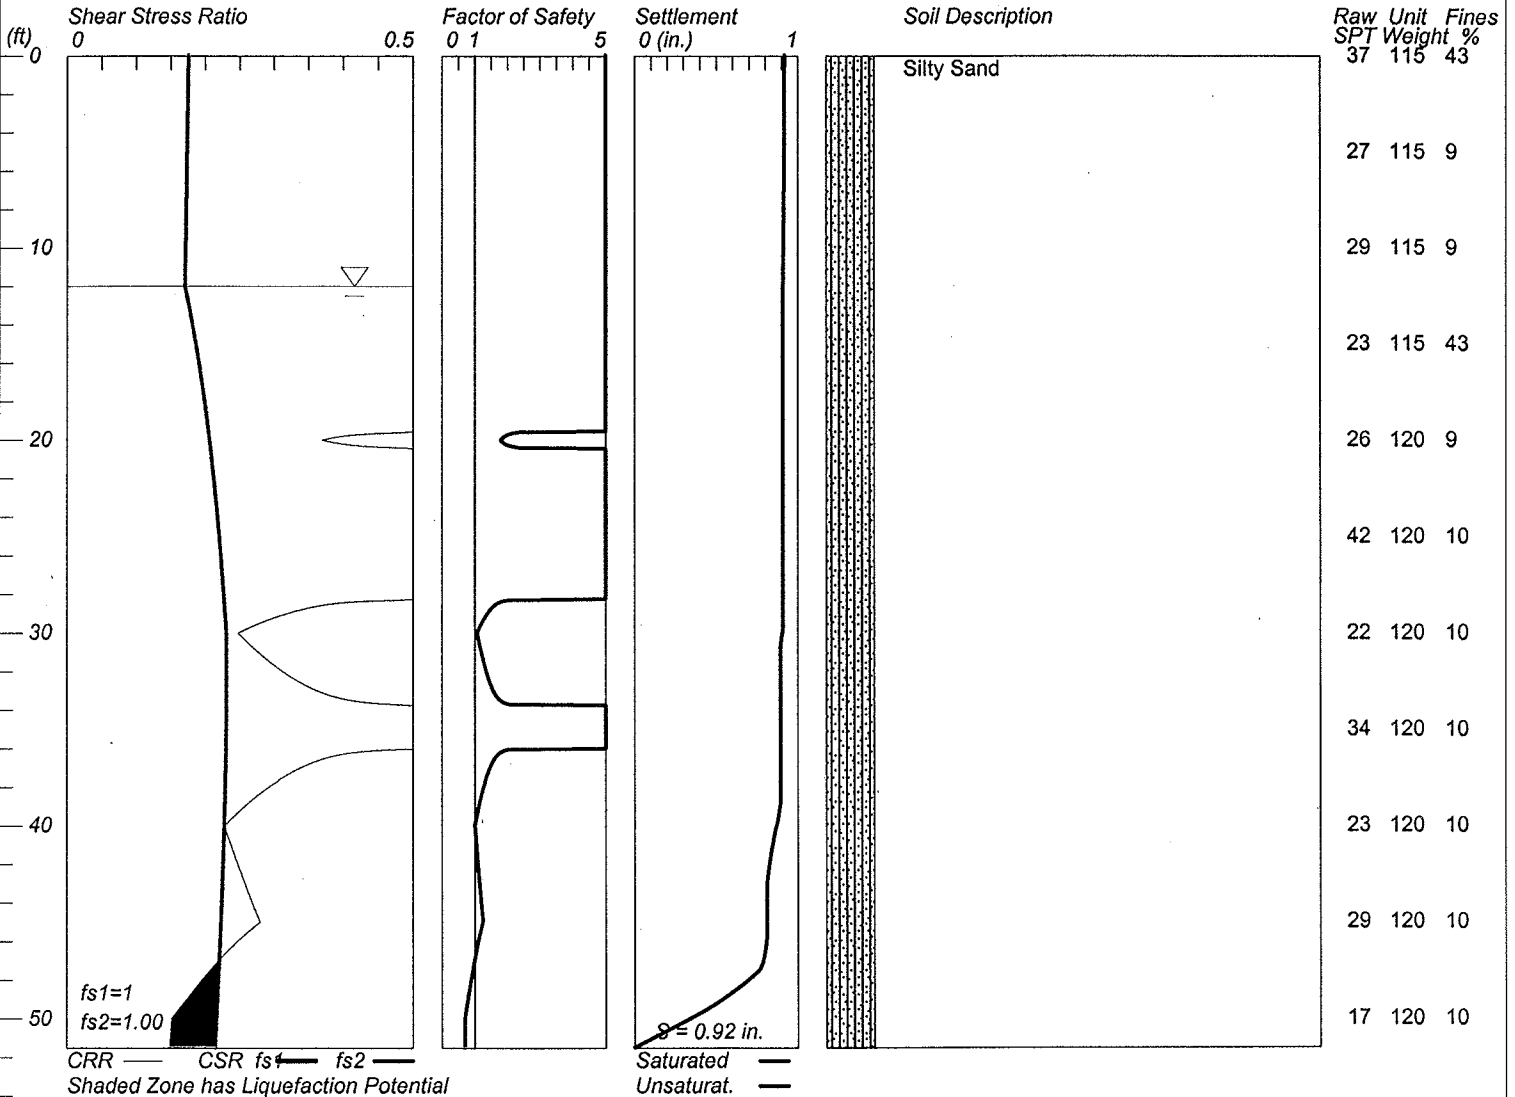
Hole No.=B-1 Water Depth=12 ft Surface Elev.=37  
 Ground Improvement of Fill=2.5 ft

Magnitude=7.5  
 Acceleration=0.27g

EUC has completed additional liquefaction analyses since the time of our last project submittal. Our analyses were based on the geotechnical data indicated on our exploratory Borings B-1 through B-5 (drilled January 19-20, 2005) and CPT soundings CPT-1 through CPT-8 (obtained May 4, 2006). These additional soil liquefaction analyses (attached) were calculated using the CivilTech LiquefyPro Version 5.3c computer program. The analysis of the borings incorporated Idriss and Seed (1997) fines corrections, and Tokimatsu and Seed's (1987) settlement criteria. The analysis of the CPT data included use of Modified Robertson and Wride (1997) methods and Tokimatsu and Seed's (1987) settlement methods.

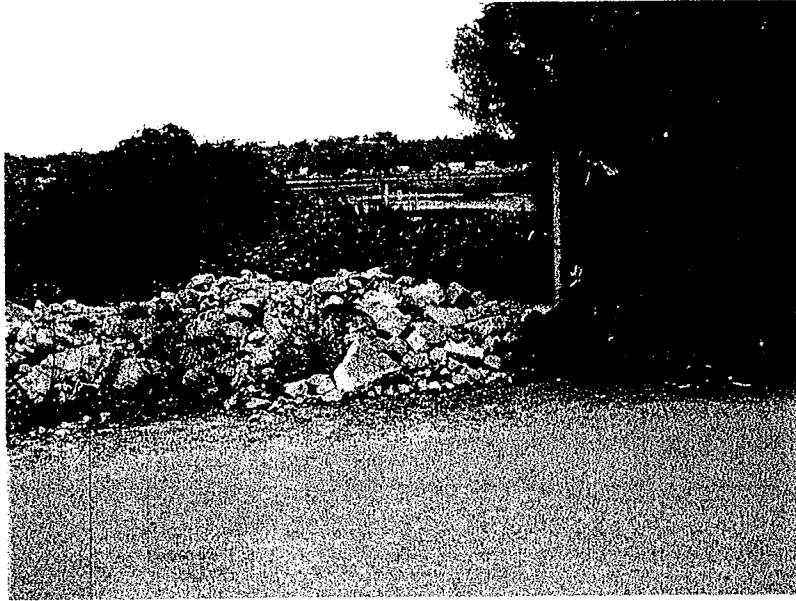
1. West view near southwest portion of property with pile of concrete.

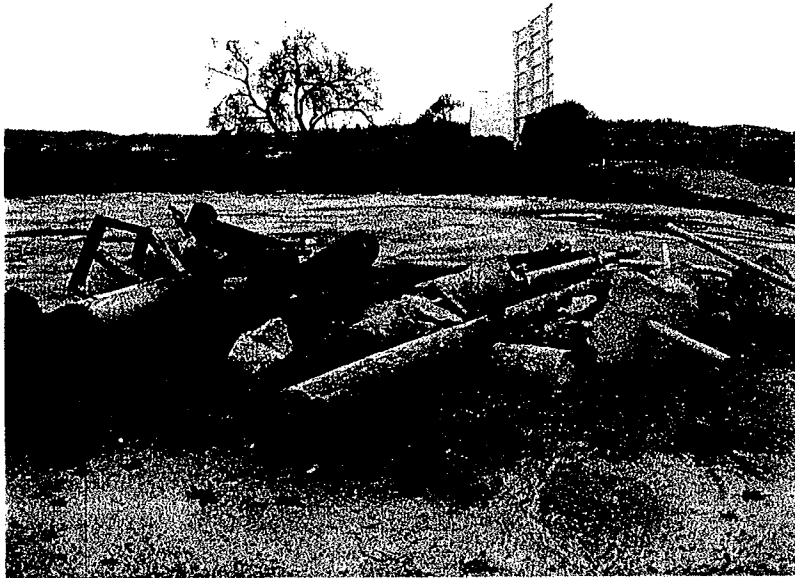
3. North view near southwest portion of property with pile of concrete and metal foundations.
