UPDATE GEOTECHNICAL INVESTIGATION

OLIVE PARK APARTMENTS
OLIVE DRIVE
OCEANSIDE, CALIFORNIA

MARCH 12, 2024
REVISED DECEMBER 17, 2024
PROJECT NO. G3035-52-01

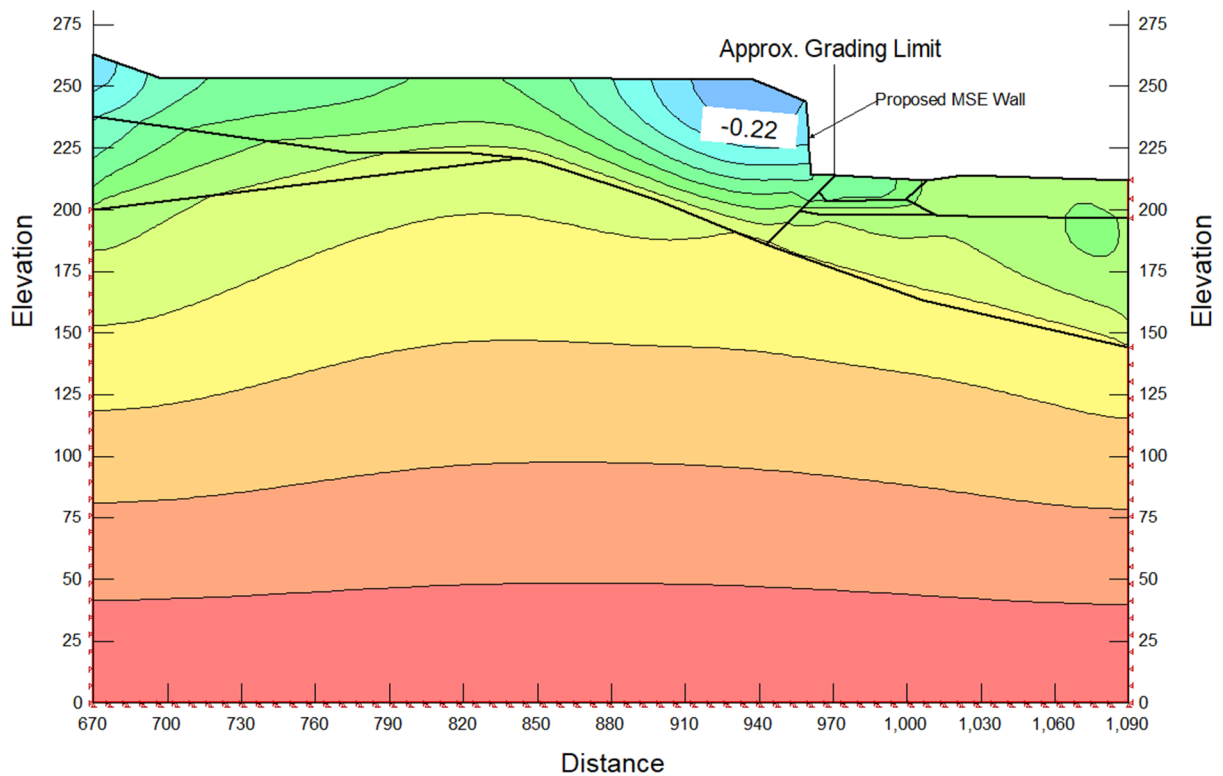
Vertical Settlement Analysis – Western Portion of Retaining Wall

The amount of settlement that could occur is a function of how thick the fill layer is, how compressible the existing layer is, and the magnitude of the new vertical load (weight of new fill or future building loads). We performed a settlement evaluation using Geostudio2018 (SigmaW). Based on laboratory test results and engineering analyses, we estimate theoretical maximum settlements of up to 3 inches (0.22 feet) and 3.6 (0.3 feet) inches for the retaining wall and western parking lot, respectively. The following figures present the computer output of our static condition settlement analyses for the retaining wall and parking lot (with settlements indicated in feet).

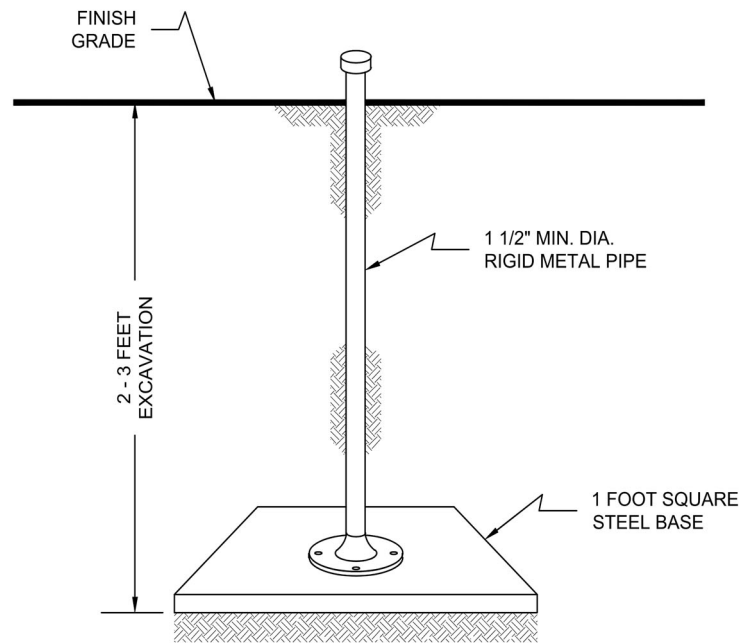
Surface Settlement Monument Detail

- 8.10.3 Surface settlement monuments should be installed at finished grade after the placement of fill in areas where compressible surficial materials will be left in place to monitor settlement movement of the underlying fill and surficial materials thereafter. A typical surface settlement monument detail is presented herein.

- 8.10.4 The project surveyor should record the movements of the surface settlement monuments every two weeks until data indicates that the rate of primary fill and left in place surficial material soil compression is essentially non-detrimental (settlement monument data with a relatively level plateau) to proposed improvements. When we receive two to three data points of settlement values that show a relatively level settlement slope on the graphs, the construction of the building and surrounding improvements can begin.

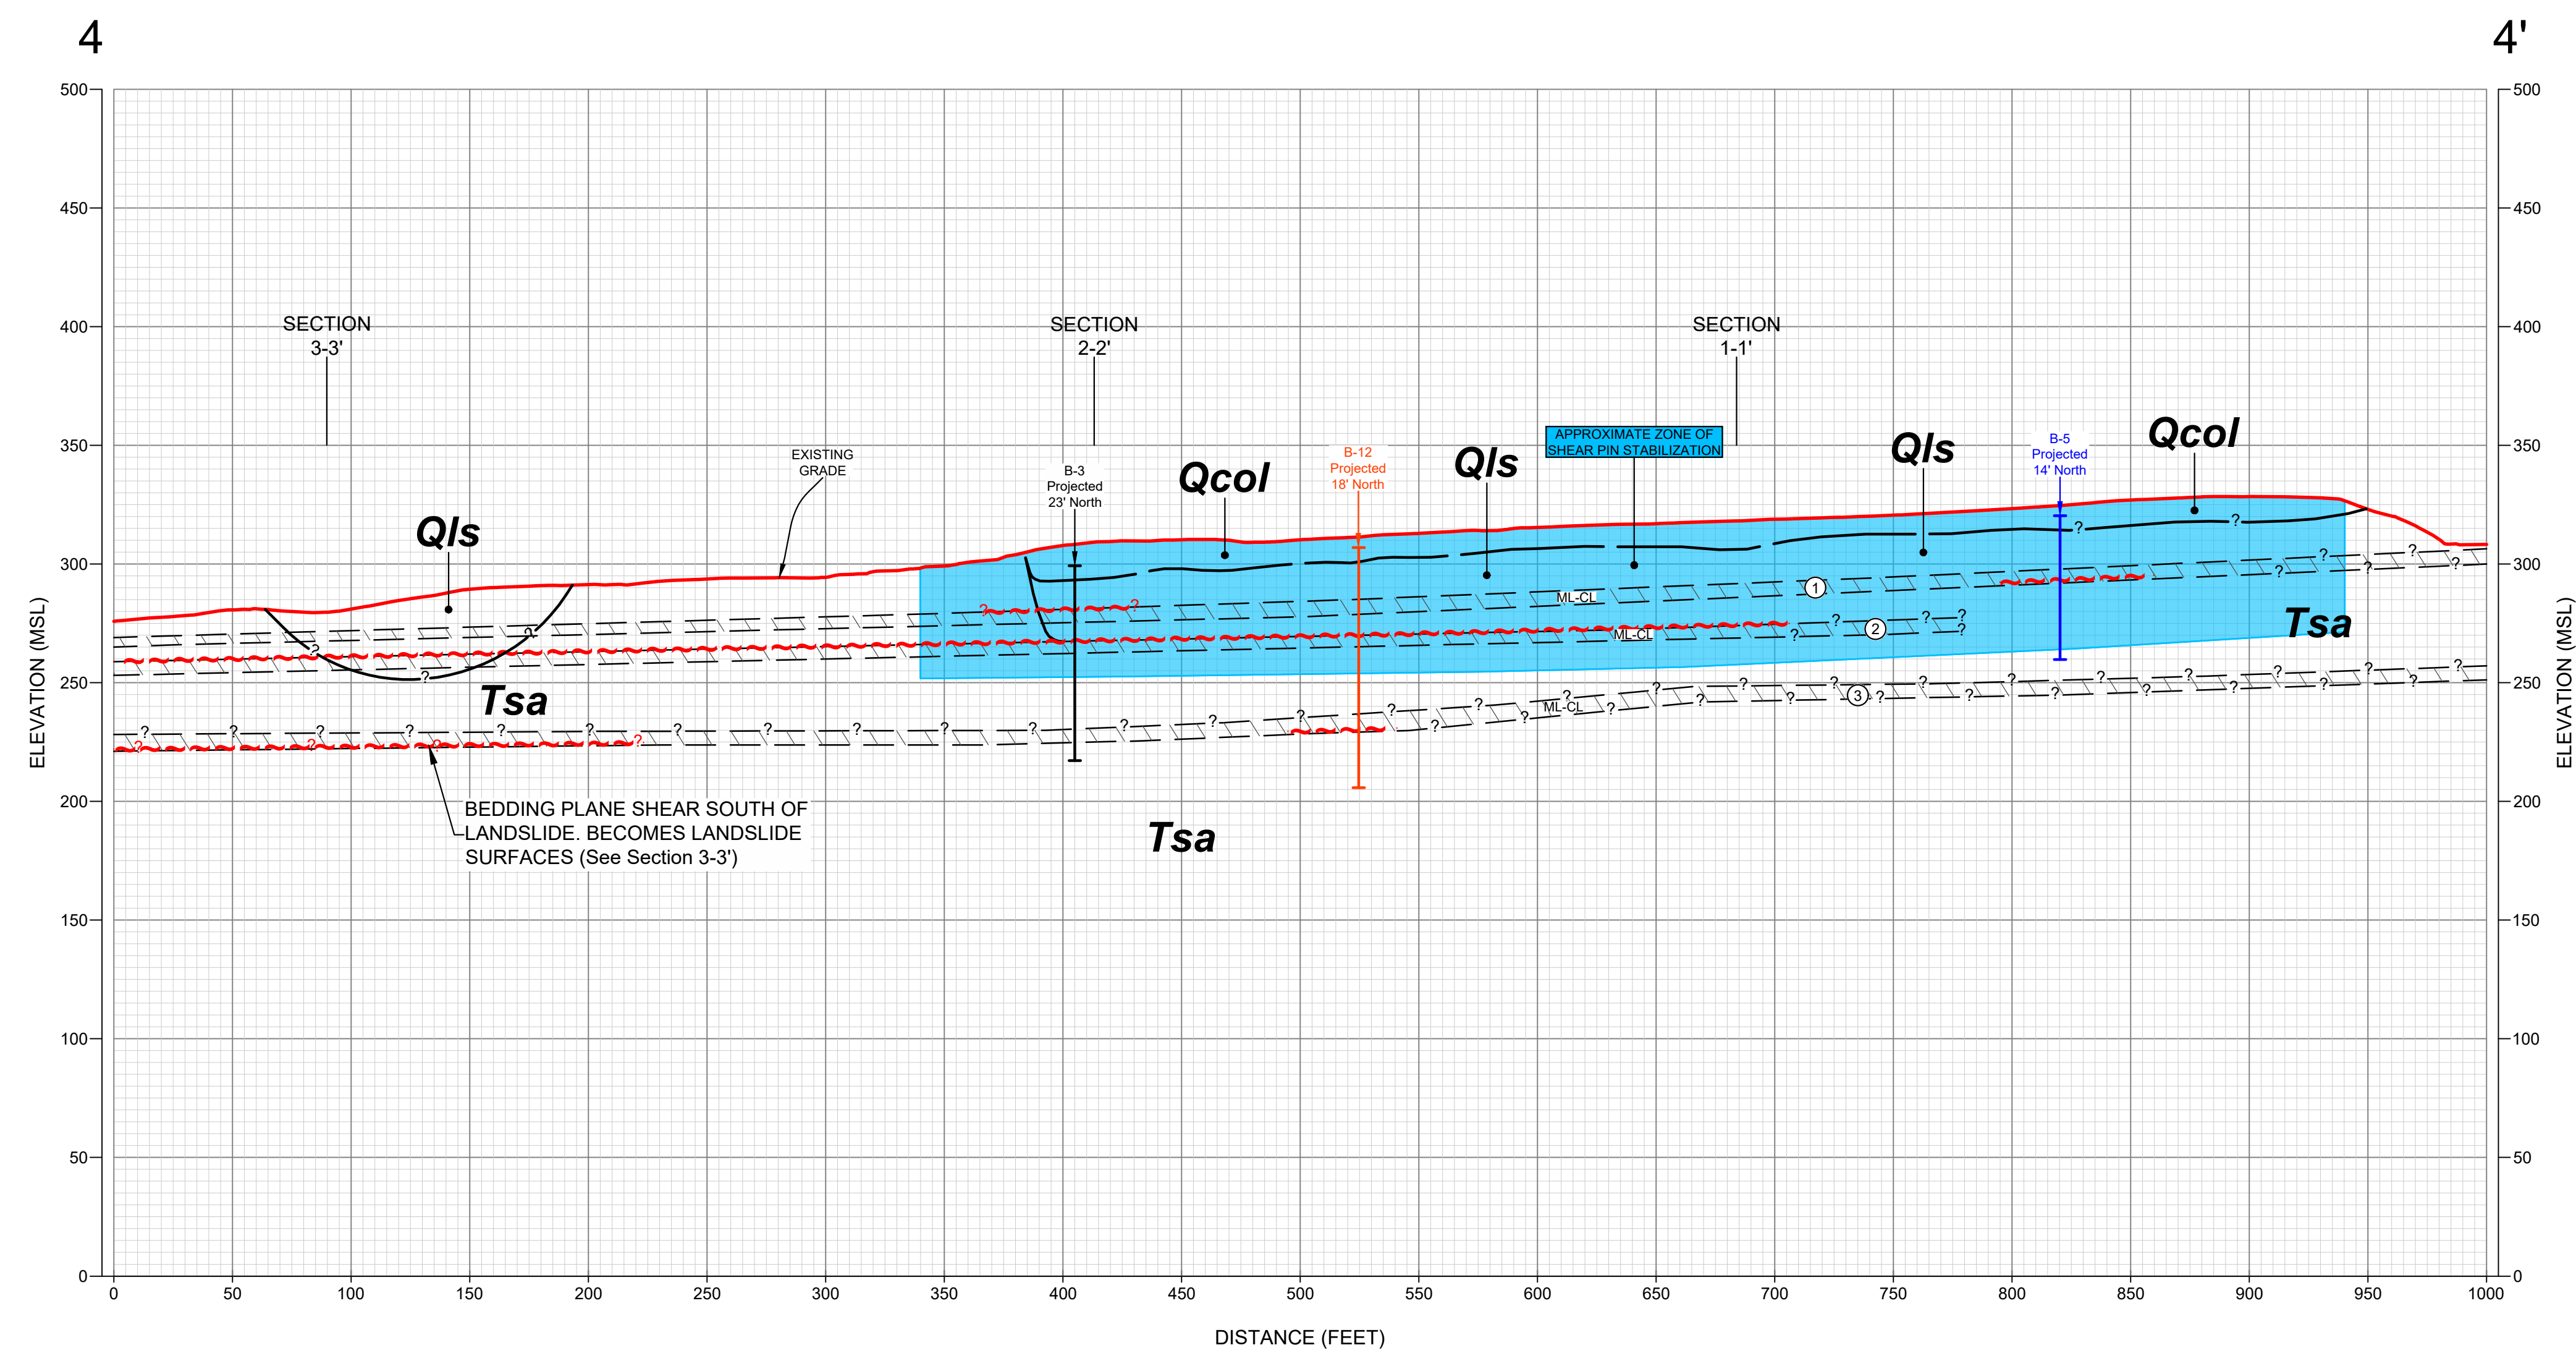
GEOLOGIC CROSS-SECTION 3-3'
SCALE: 1" = 50' (Vert. = Horiz.)

GEOLOGIC CROSS-SECTION 4-4'
SCALE: 1" = 50' (Vert. = Horiz.)

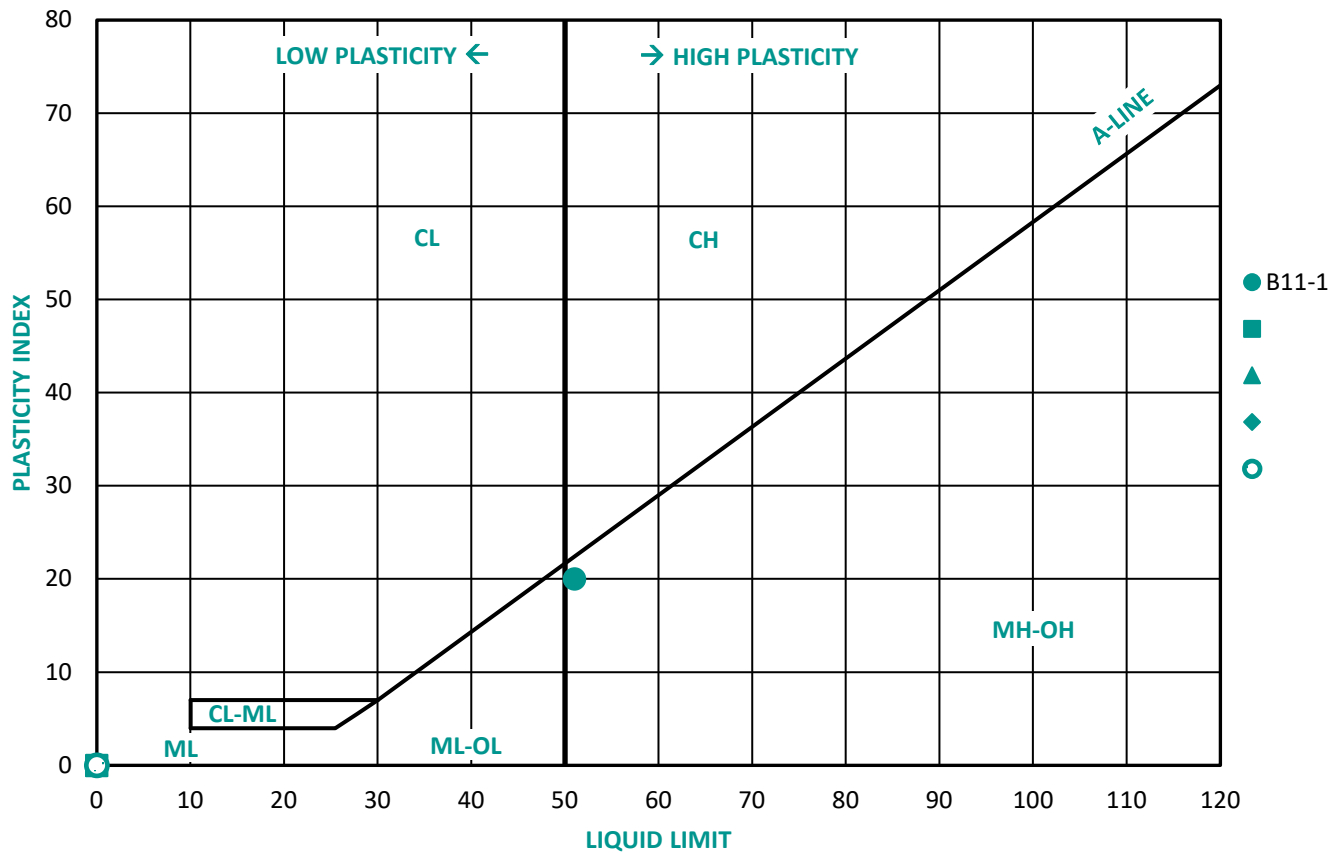
TEST RESULTS					
SAMPLE NO.	GEOLOGIC UNIT	LIQUID LIMIT	PLASTIC LIMIT	PLASTICITY INDEX	SOIL TYPE
B11-1	Qls	51	31	20	MH-OH

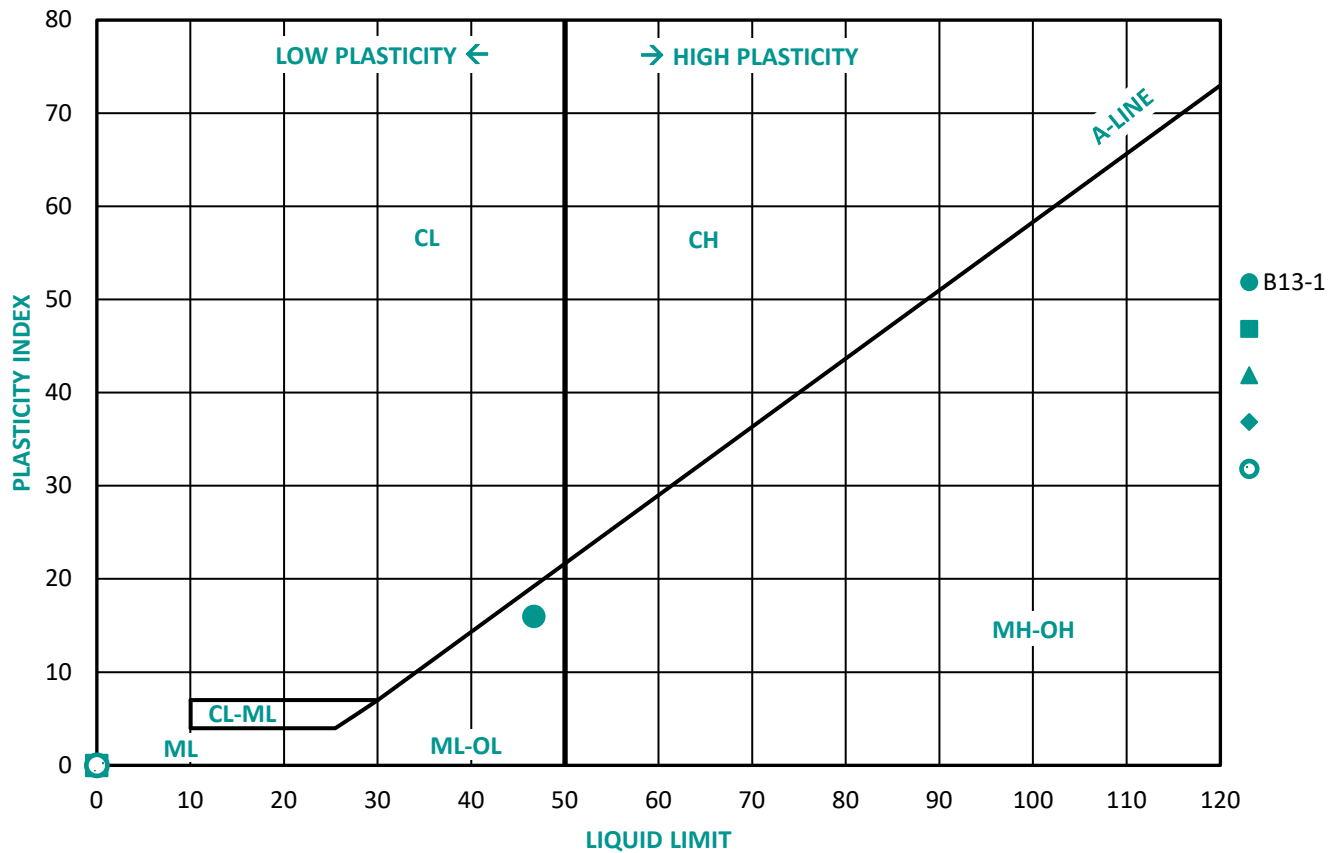
TEST RESULTS					
SAMPLE NO.	GEOLOGIC UNIT	LIQUID LIMIT	PLASTIC LIMIT	PLASTICITY INDEX	SOIL TYPE
B13-1	Qls	47	31	16	ML-OL

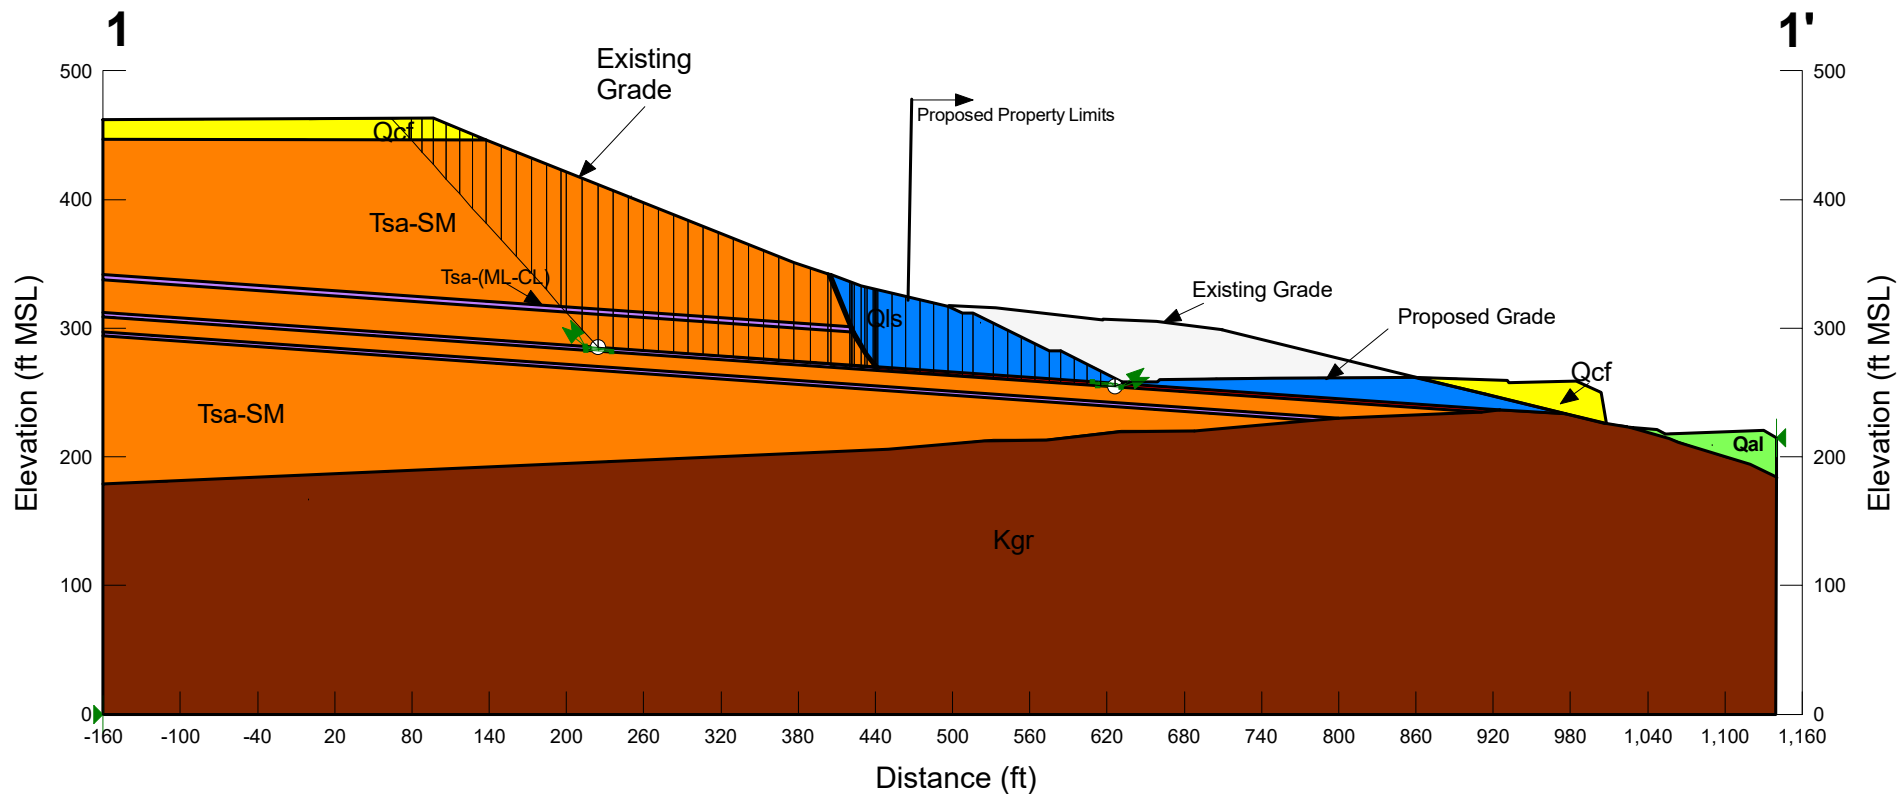
1-1'

Proposed Grade
Static Condition

Olive Street
Project No. G3035-52-01
Name: Case 1_1-1'_Slide Plane.gsz

1.38

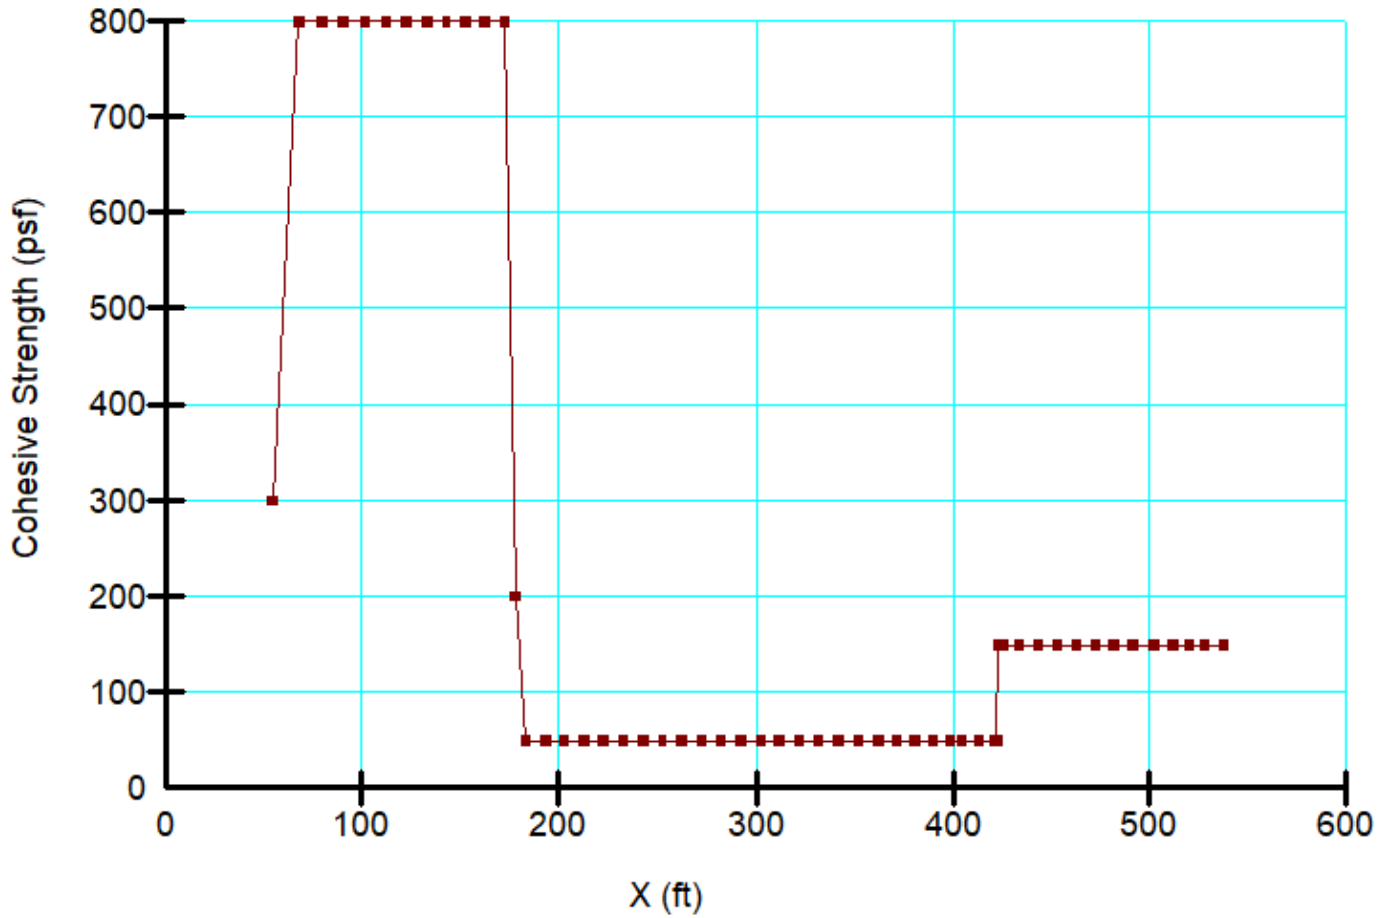
Upper Plane Cohesive Strength

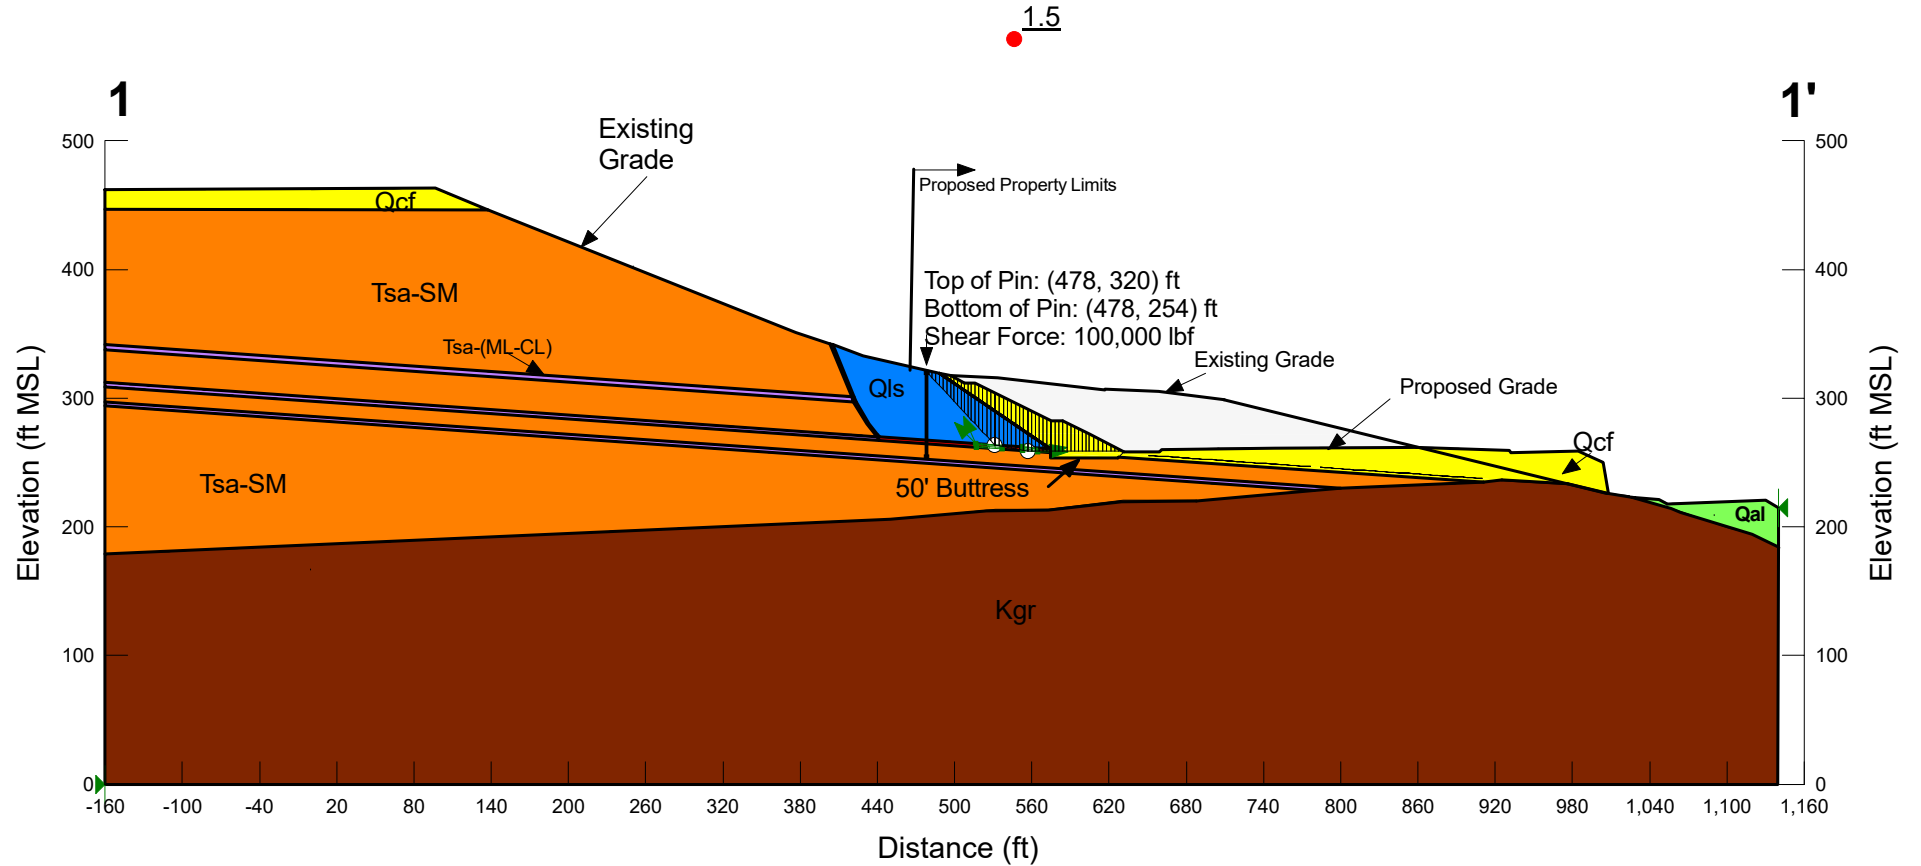
Proposed Grade
Static Condition

Olive Street
Project No. G3035-52-01
Name: Case 8_1-1'_Buttress.gsz

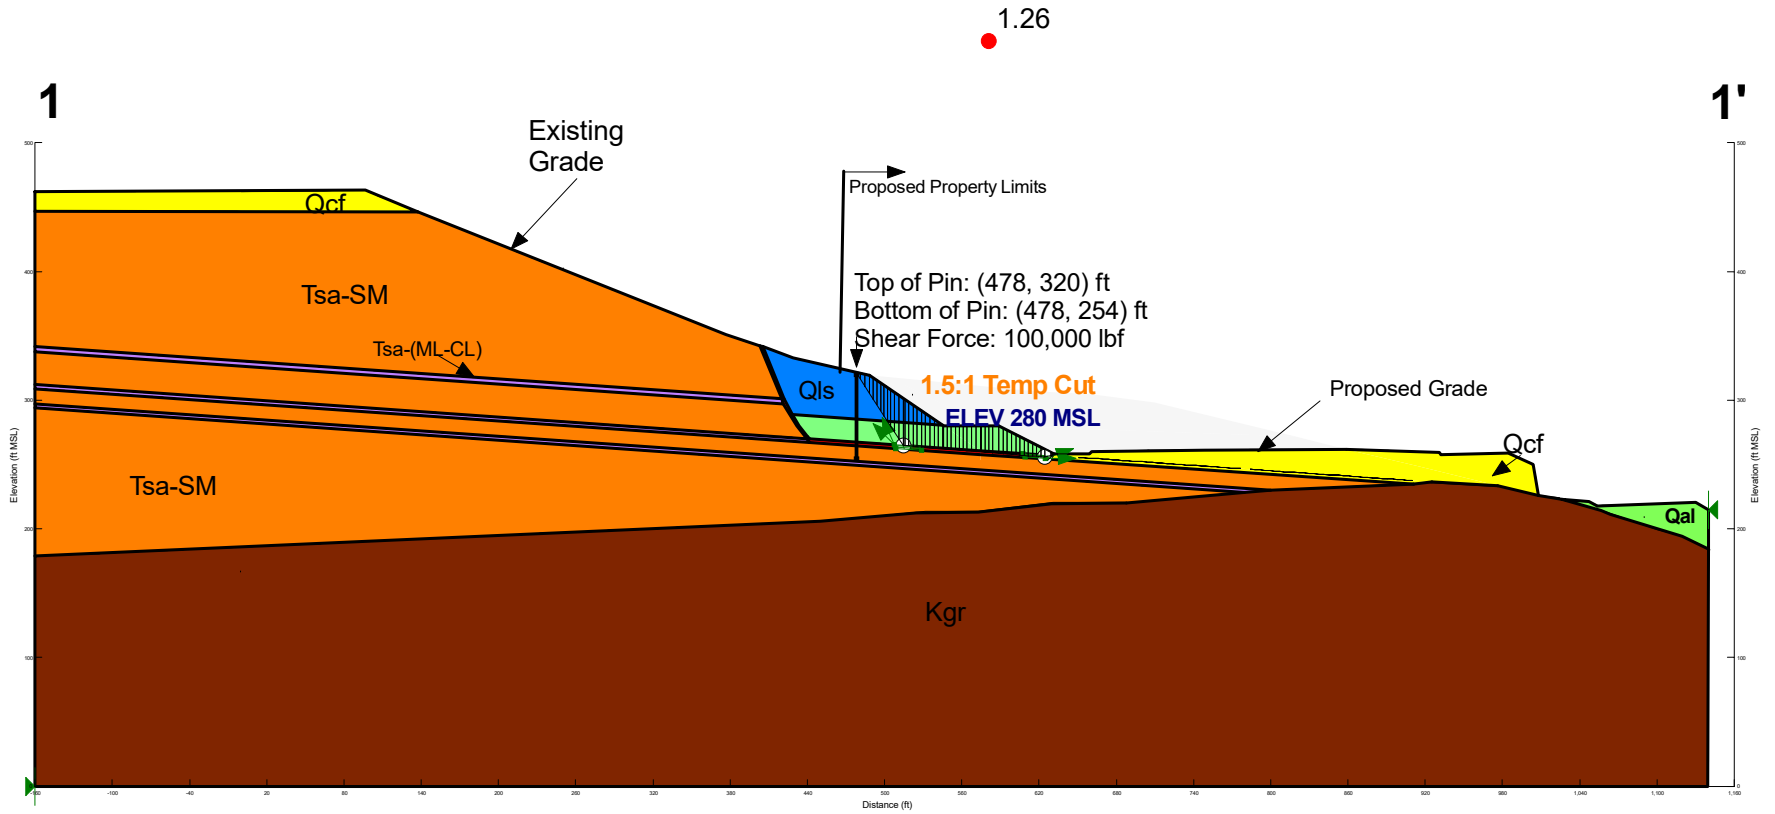
Olive Street
Project No. G3035-52-01
Name: Case 10_1-1'_Temp-block-Slot Cut.gsz

Color	Name	Unit Weight (pcf)	Cohesion' (psf)	Phi' (°)	Phi-Anisotropic Strength Fn.	C-Anisotropic Strength Fn.
■	Kgr	130	1,000	51		
■	Qal	130	150	26		
■	Qcf	130	300	28		
■	Qls	130	150	26		
■	Qlsp	130	50	14		
■	Qls-SM	130	300	30		
■	Tsa-ML	130	200	28	Phi-14°	Cohesion-50 (psf)
■	Tsa-SM	130	800	34

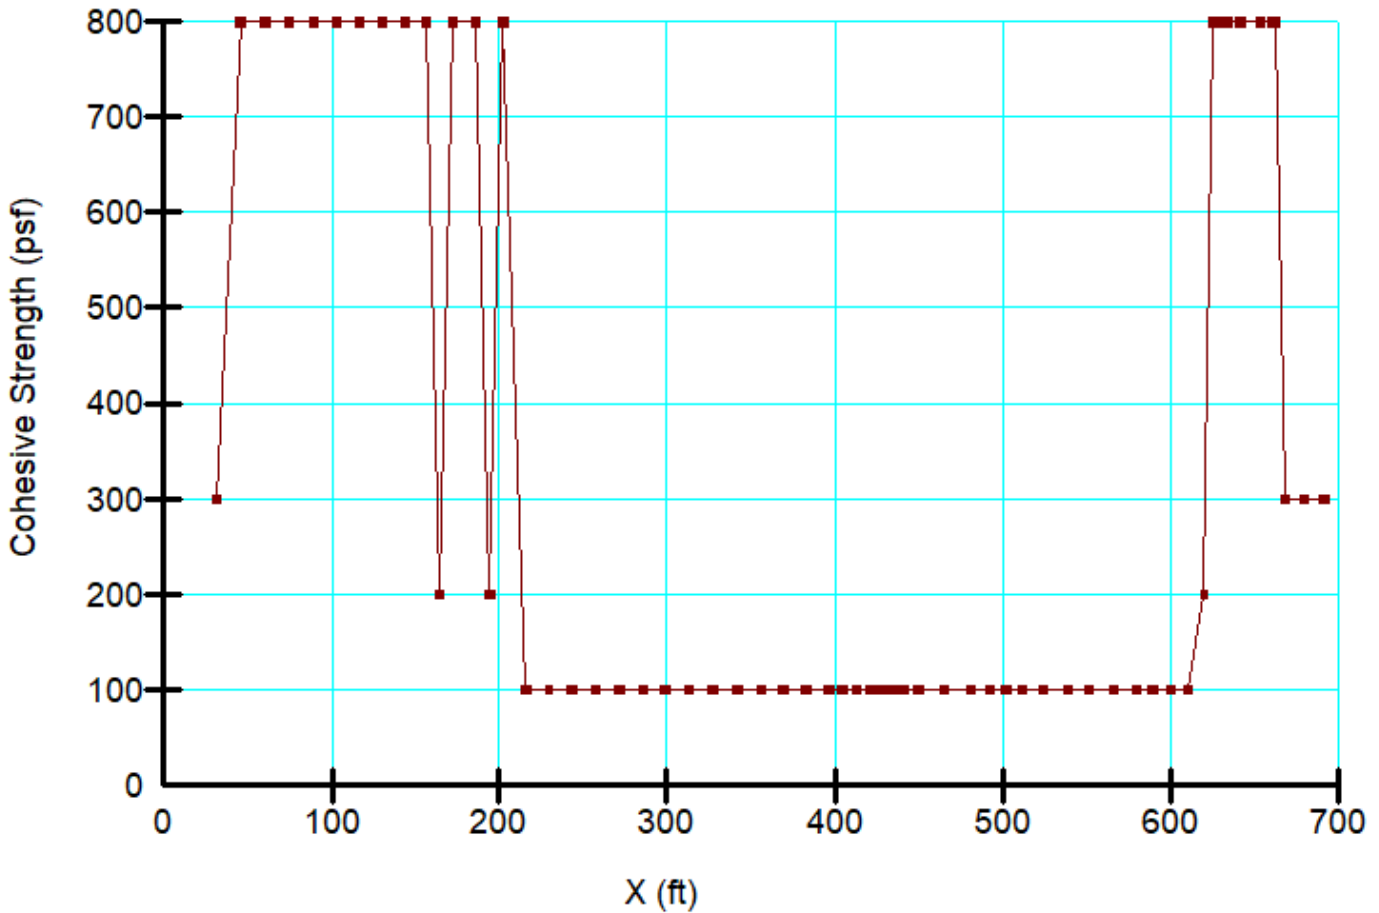
Seismic Lower-Cohesive Strength

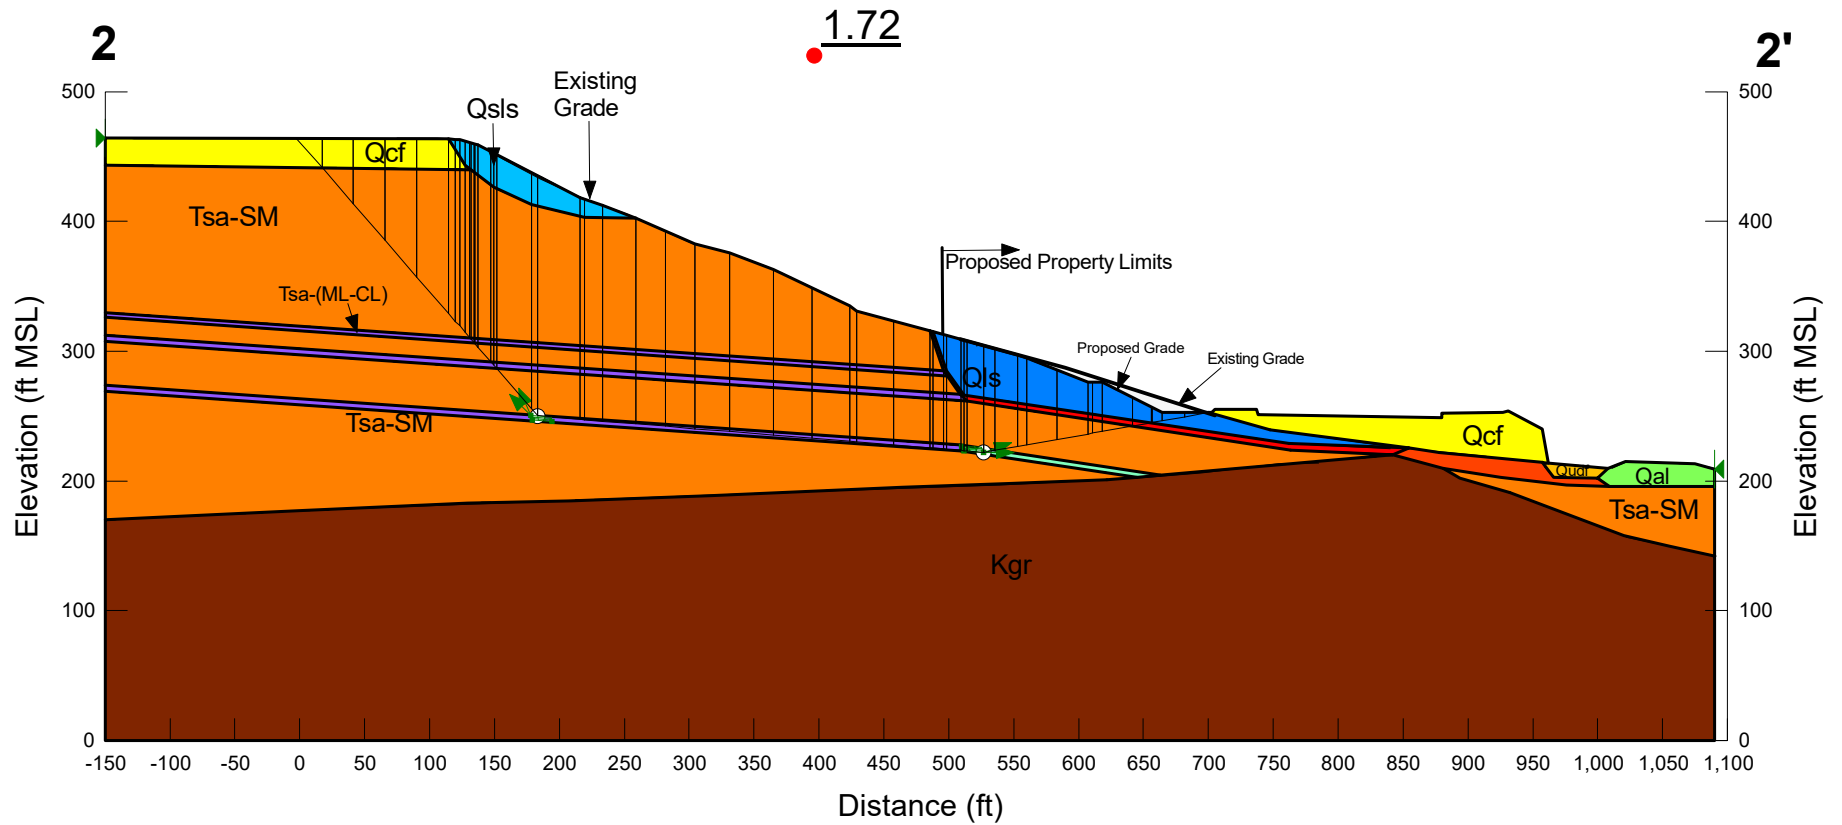
Olive Street
Project No. G3035-52-01
Name: Case 3_2-2'_ Lower Plane.gsz

**Proposed Grade
Static Condition**

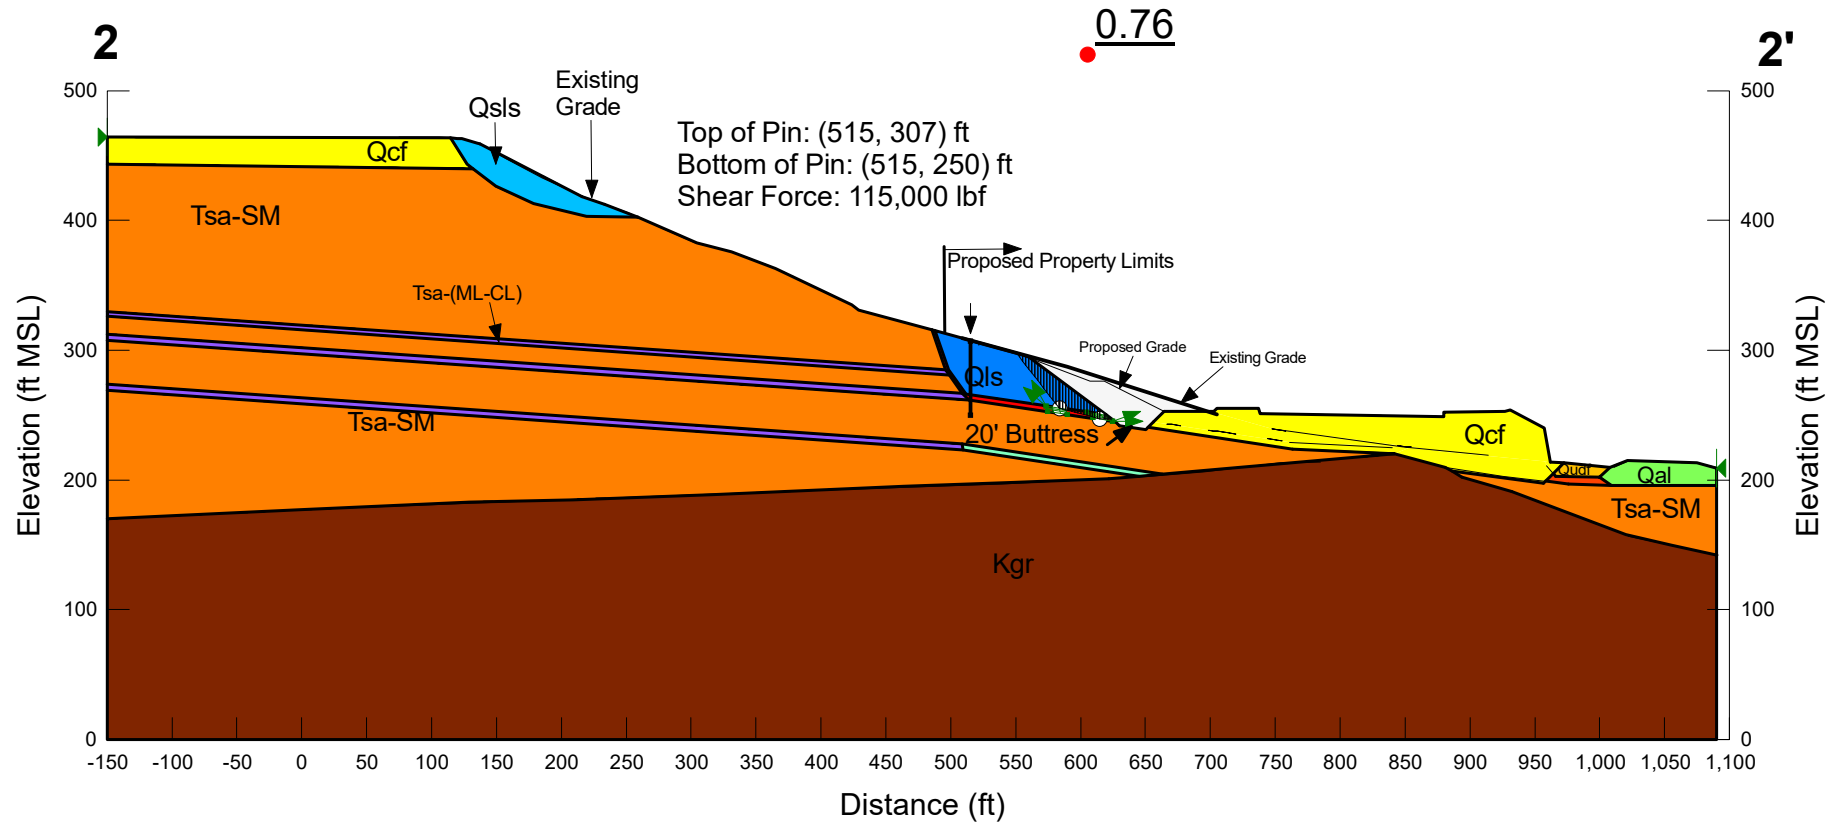
Olive Street
Project No. G3035-52-01
Name: Case 9_2-2'-Temp.gsz

**Proposed Grade
Static Condition**

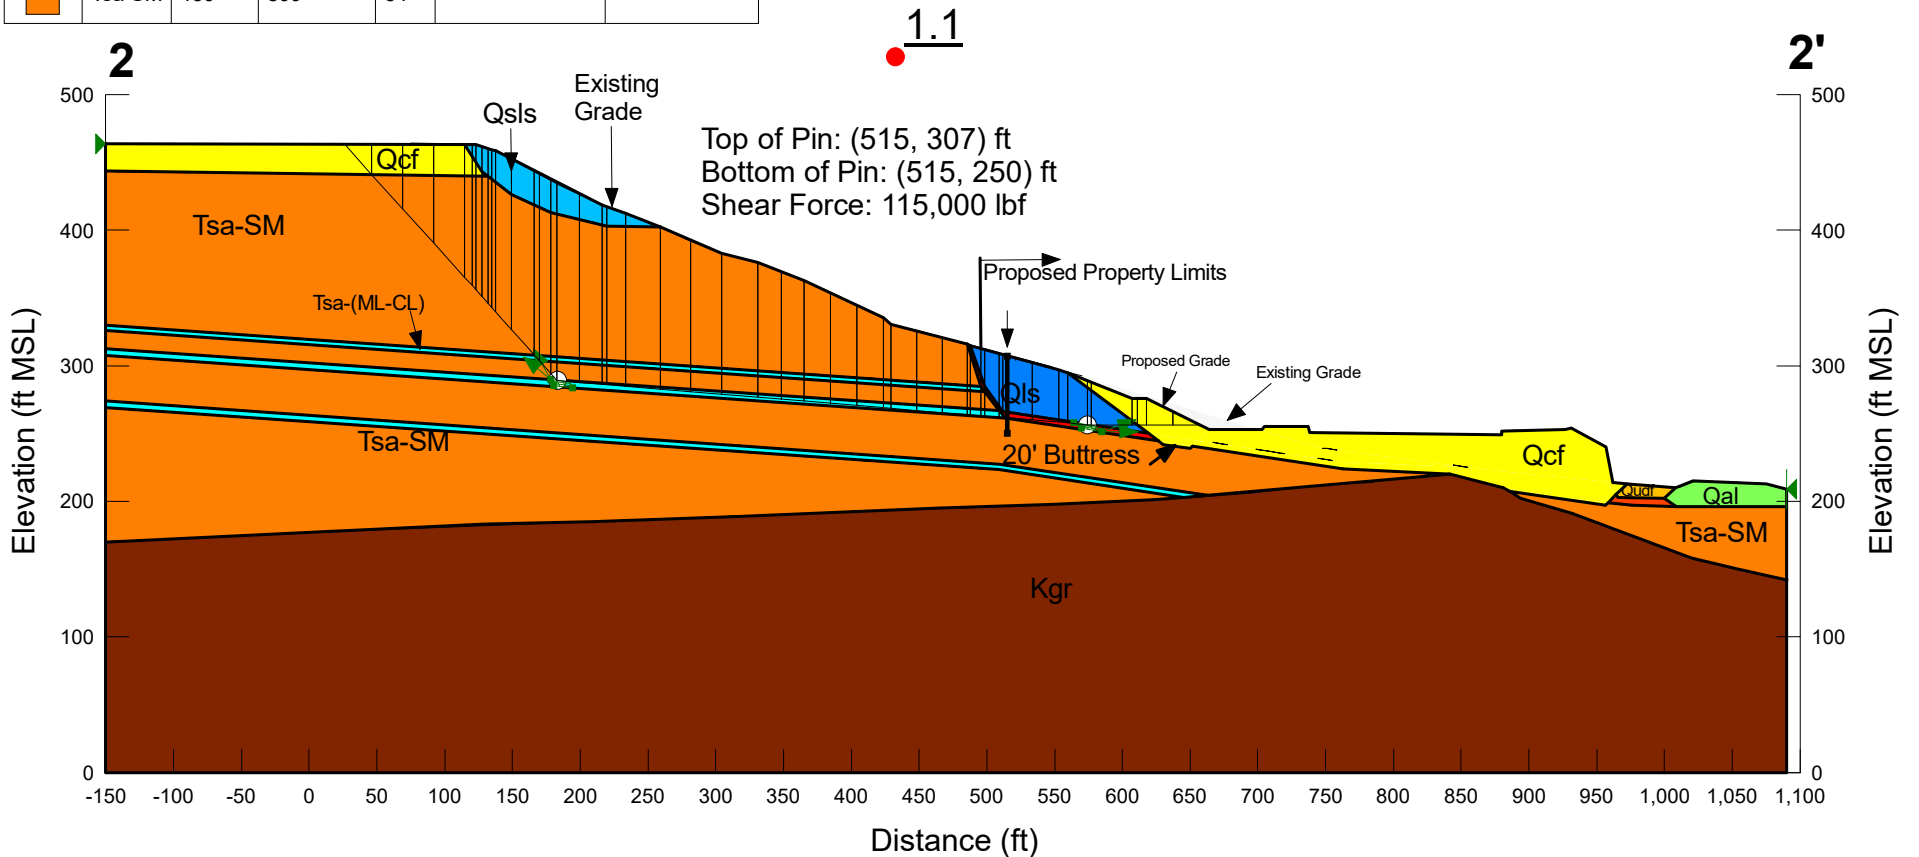
Olive Street
Project No. G3035-52-01
Name: Case 11_2-2'-Seismic.gsz

Proposed Grade
Static Condition

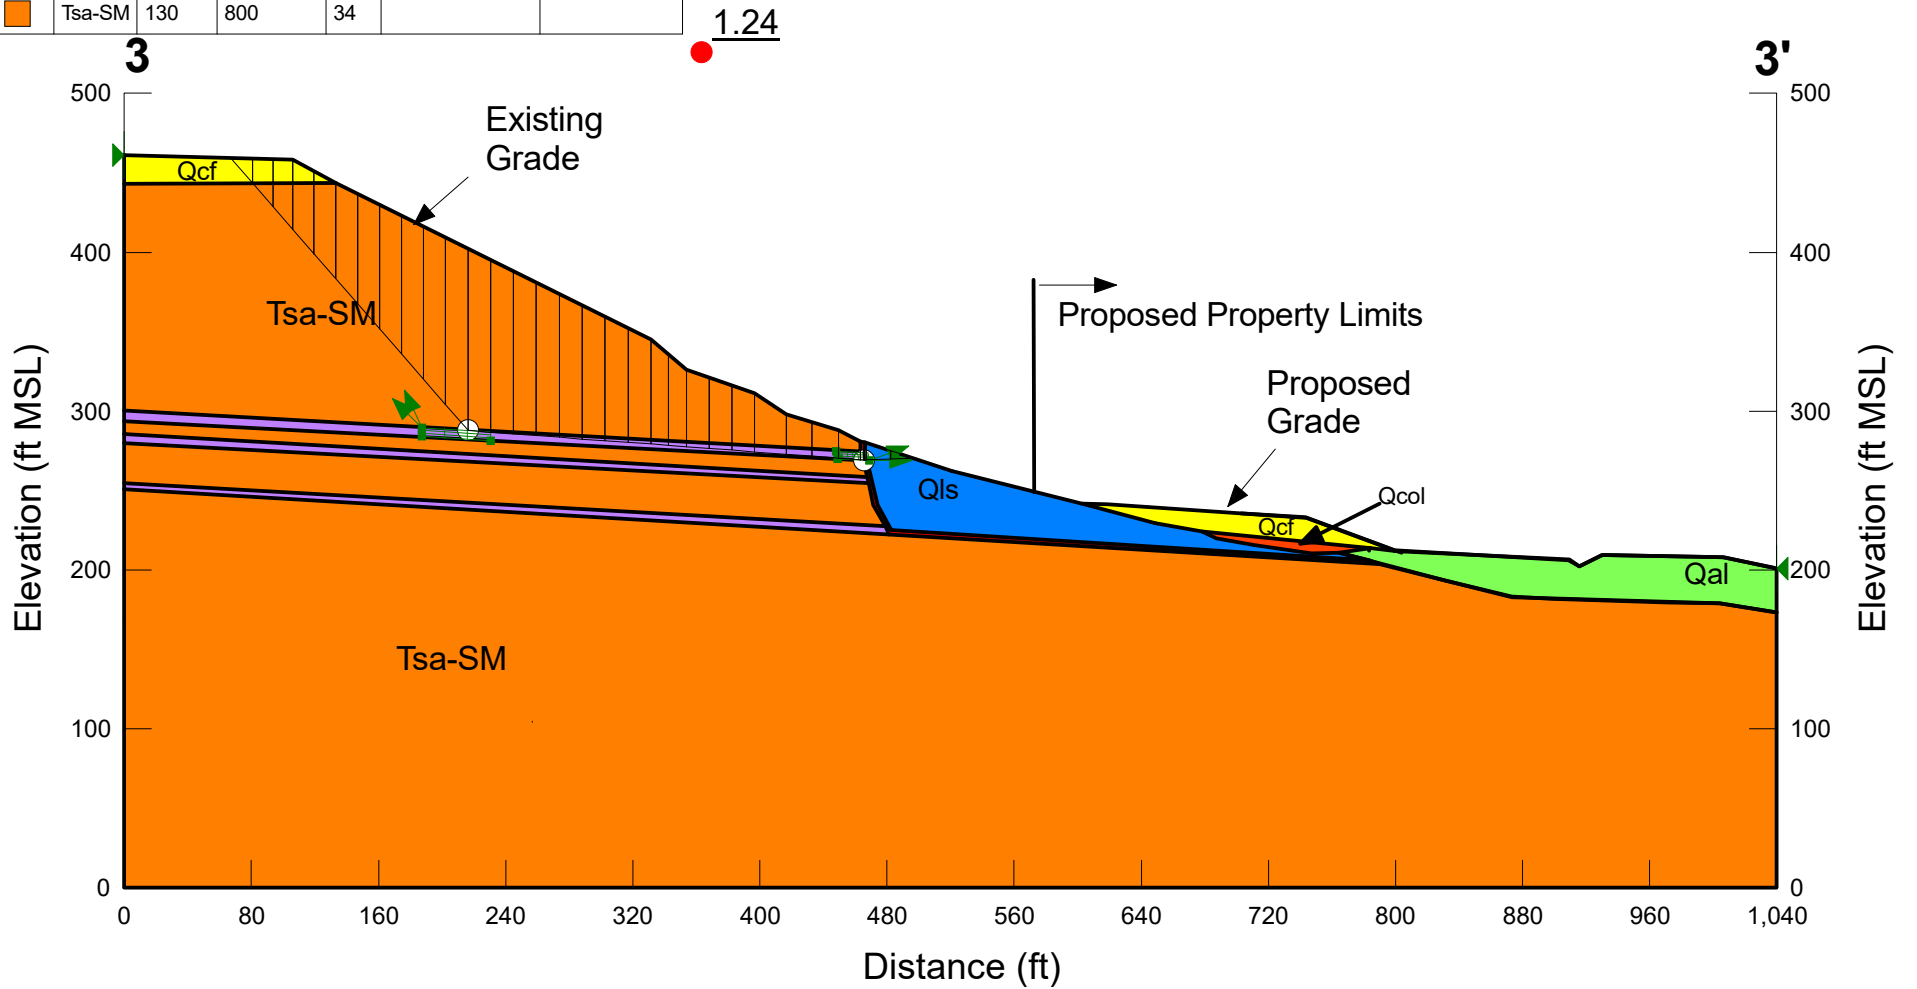
**Proposed Grade
Static Condition**

Olive Street
Project No. G3035-52-01
Name: Case 3_3-3'-Mid Plane.gsz

Color	Name	Unit Weight (pcf)	Cohesion' (psf)	Phi' (°)	Phi-Anisotropic Strength Fn.	C-Anisotropic Strength Fn.
Light Green	Qal	130	150	26		
Yellow	Qcf	130	300	28		
Red	Qcol	125	150	26		
Blue	Qls	130	150 </td <td>26</td> <td></td> <td></td>	26		
Red	Qlsp	130	50	14		
Purple	Tsa-ML	130	200	28	Phi-14 °	Cohesion-50 (psf)
Orange	Tsa-SM	130	800	34
